Vessel Head Penetration Cracking in Nuclear Reactors

Part I Nuclear Vessel Head Penetration Cracking in France

Part II The International Perspective

March 1993

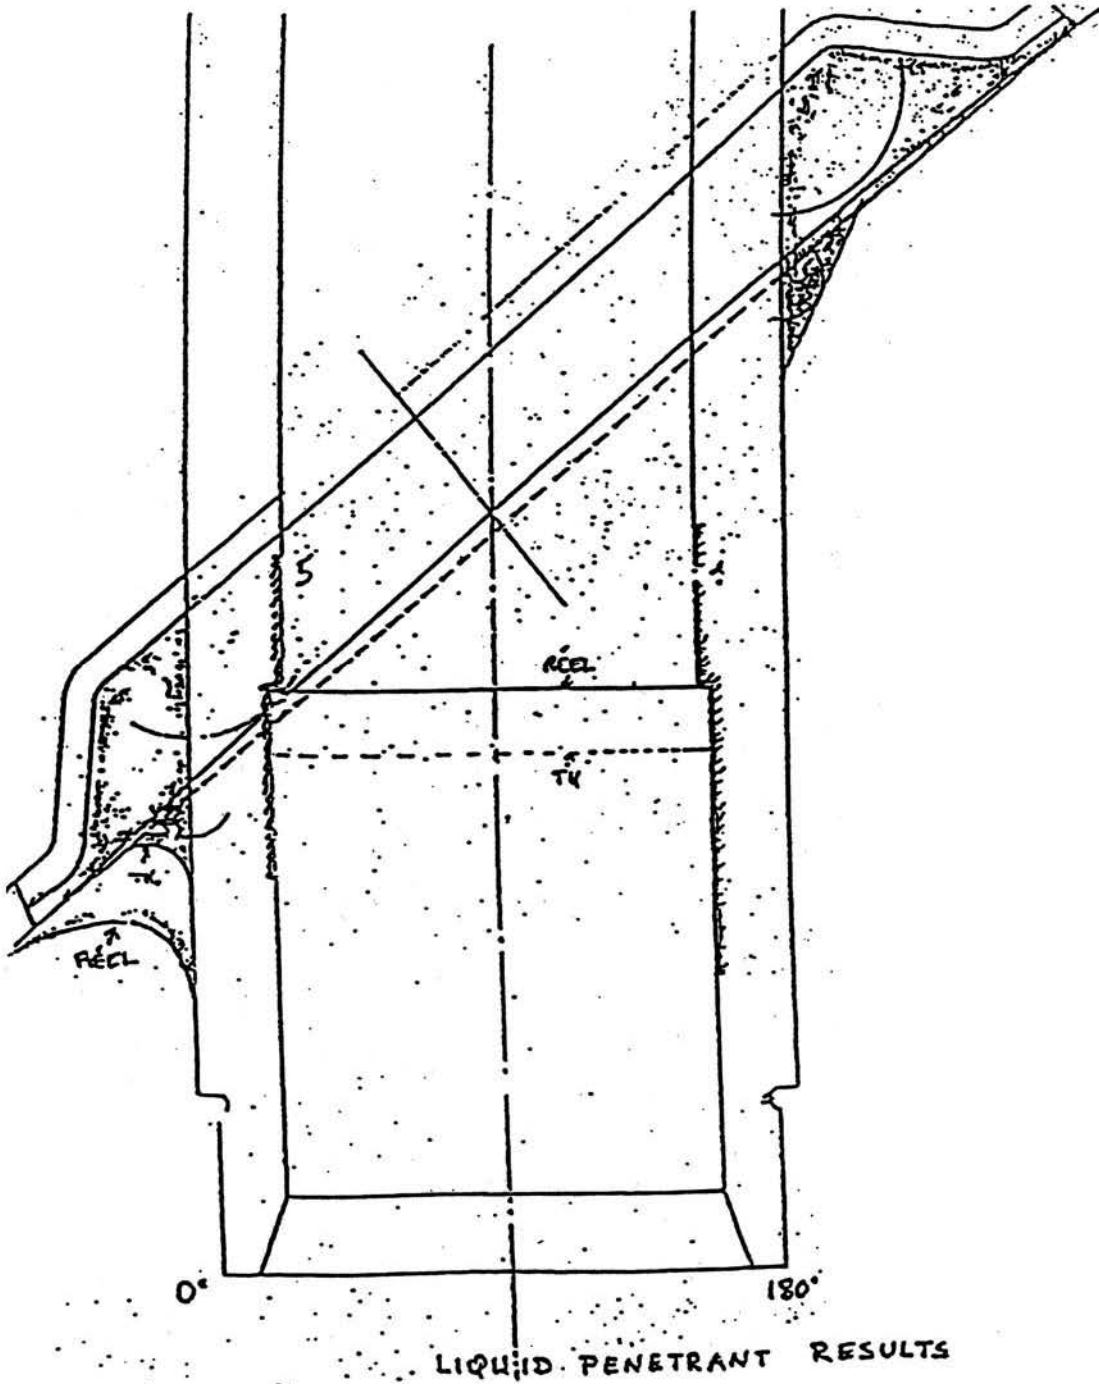
Figure II.2: Findings of VHPC at Bugey-3⁹⁵

By the middle of October 1991 investigations had revealed 11 longitudinal cracks of 15 to 73 mm length occurring in two groups on the inner wall of the incriminated VHP of the Bugey-3 reactor. Four external tracks indicated penetrating cracks of which only two were thought to have caused the leak. In addition the tube itself had become somewhat oval.
